ANALYTICAL RESULTS REPORT

RICO ARGENTINE
Rico, Dolores County, Colorado

CERCLIS ID No. COD980952519

EPA Contract No. 68-W5-0031
TDD No. 9511-0015

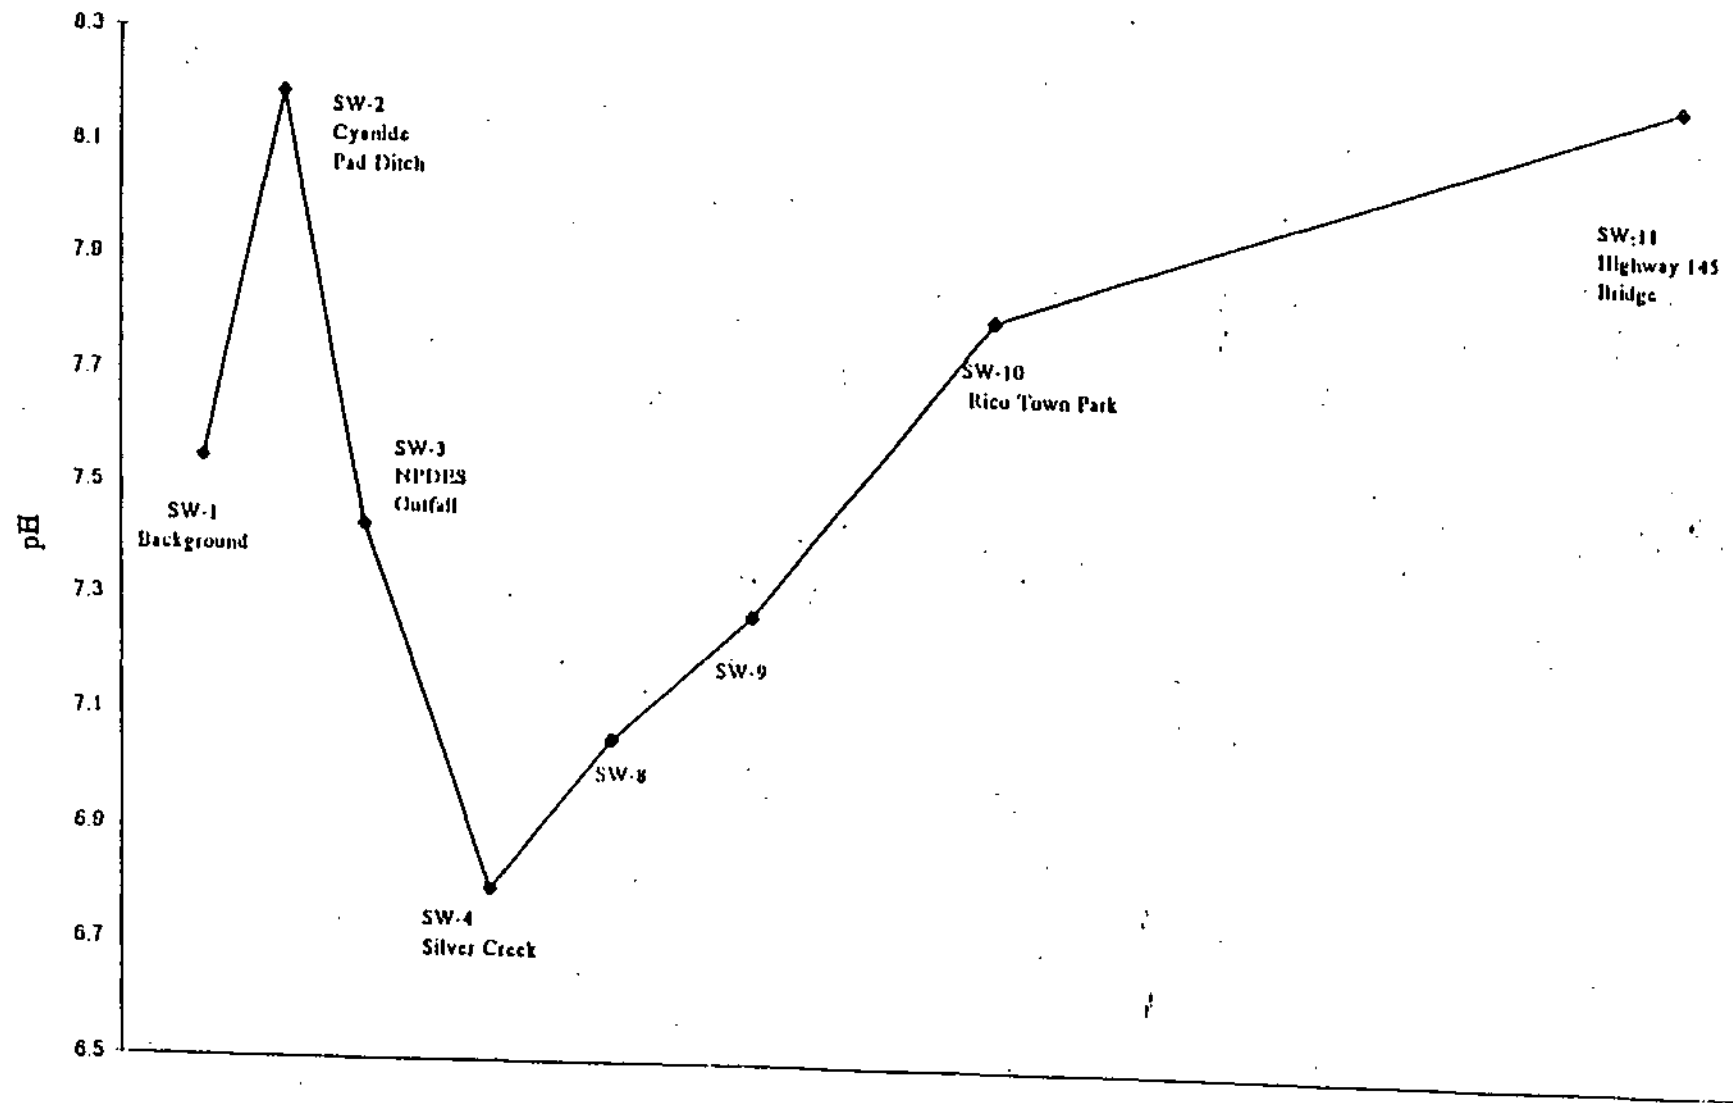
Figure 3

pH on Dolores River

Distance Between Water Quality Stations Has Been Approximated

The measured pH of the Dolores River increased at sample location RA-SW-02 to pH 8.19. Sample location RA-SW-02 is on the east bank of the Dolores River immediately adjacent to the uppermost settling pond. The upper most settling pond is separated from the Dolores River by an unlined berm which is approximately 50 feet wide and a ditch which flows adjacent to the cyanide leach pits and uppermost settling pond. The pH of the water in the uppermost settling pond was 8.28. Infiltration of settling pond water through the berm into the Dolores River could possibly be the cause of the high pH reading at sample station RA-SW-02.

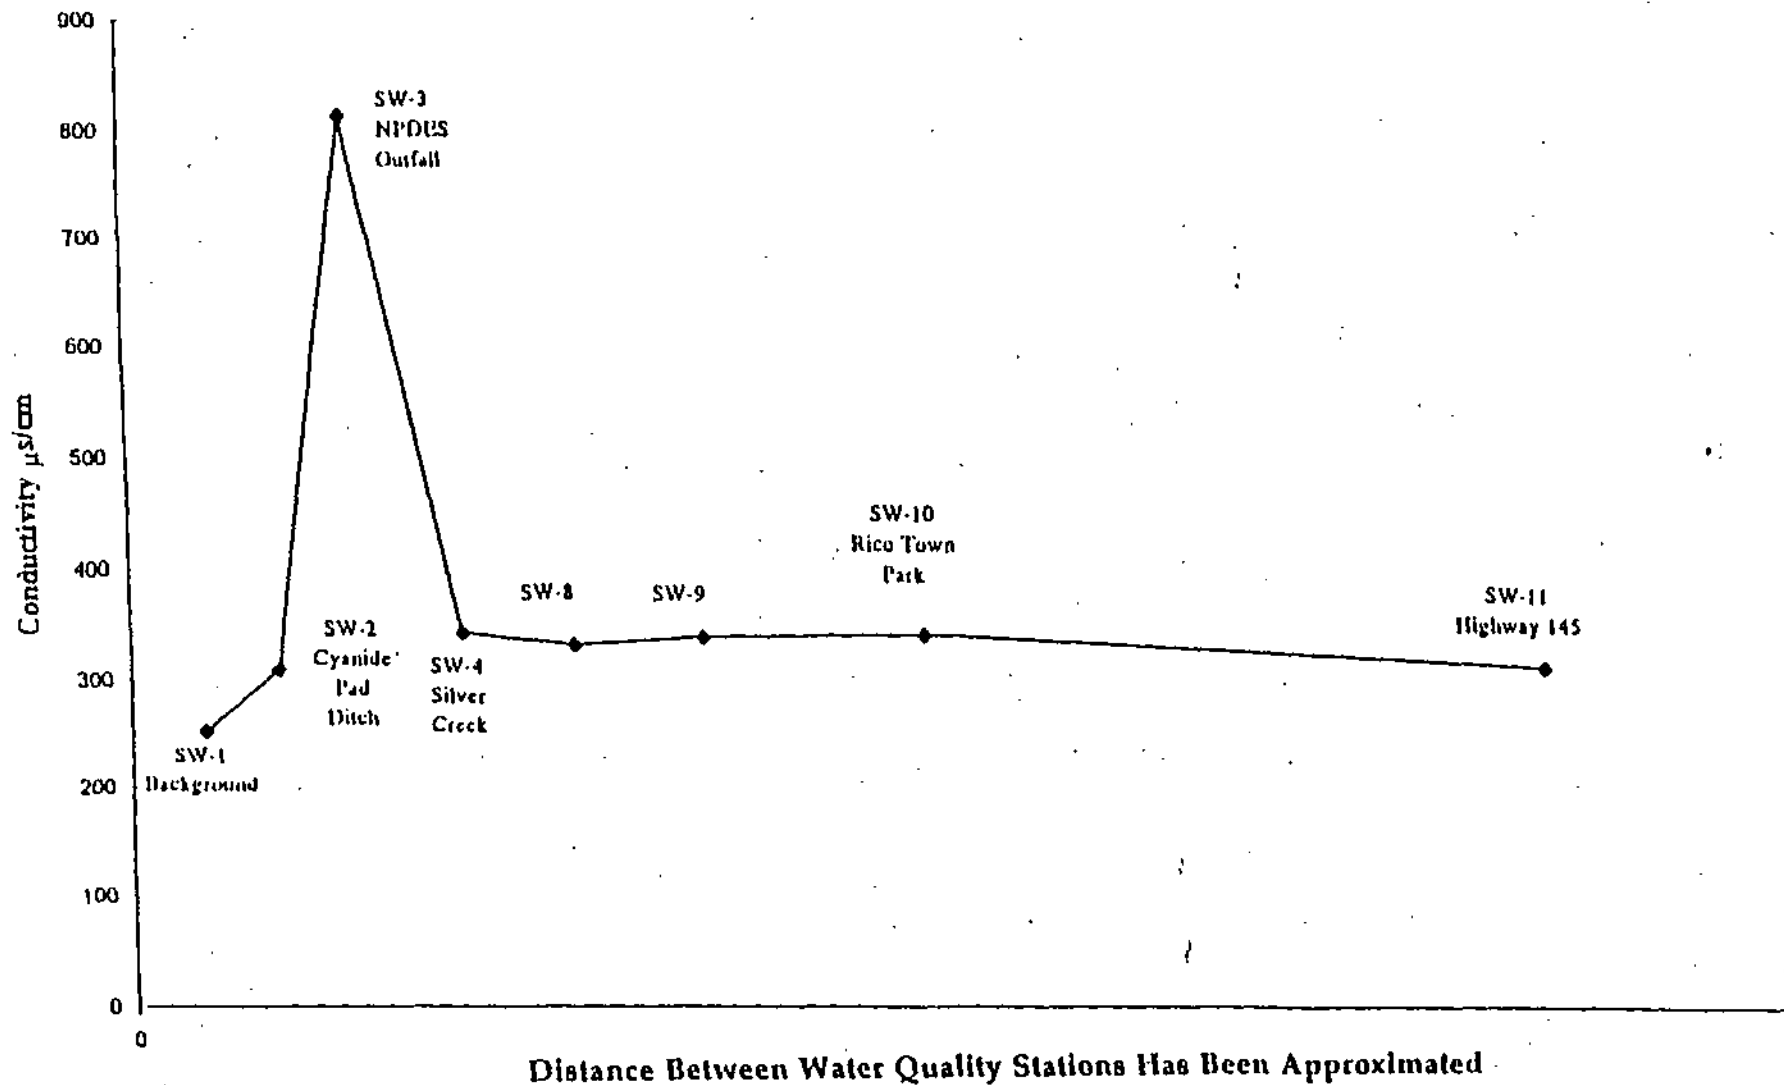
Figure 4

Conductivity on Dolores River

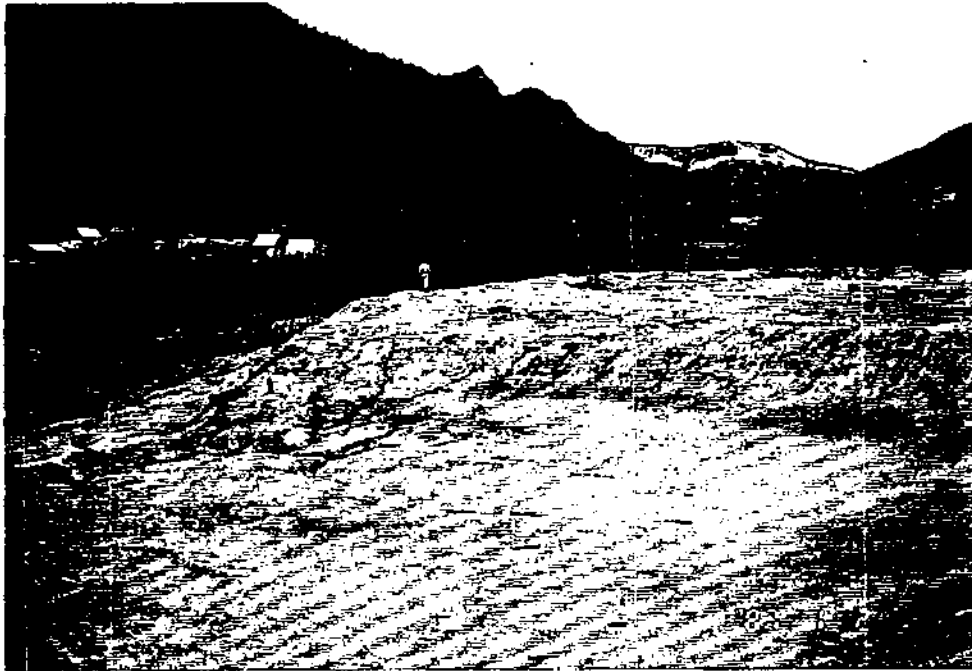
PHOTO 12

View of tailings pile at RA-SW/SE-08 just south of town of Rico. Dolores River is on the left side of photo where it is actively eroding the tailings. Tailings were sampled as RA-WSO-06.

Source areas are posted but are not secured from public access. There are several locations along Silver Creek and the Dolores River where tailings were noted to be slumping into surface water bodies. The settling ponds along the Dolores River are in good condition and no evidence of a spill was located during the field work (URS 1995b).

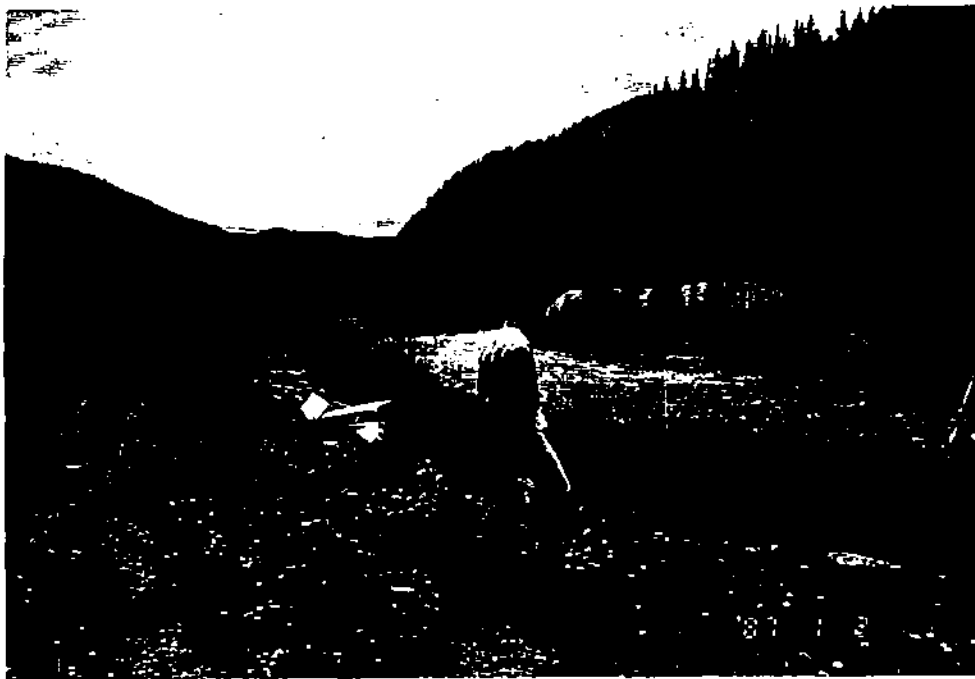
PHOTO 13

View to south along Dolores River of tailings pile split by Dolores River at RA-SW/SE-09. Tailings on left (east) side of river were sampled as RA-WSO-09.
